PHOTOGRAPHIC INTERPRETATION REPORT

SOUTHEAST ASIA ACTIVITY REPORT

SELECTED TRANSPORTATION
AND INFILTRATION
COMPENDIUM
25-31 AUGUST 1966

NPIC/R-309/66 SEPTEMBER 1966 25X1C

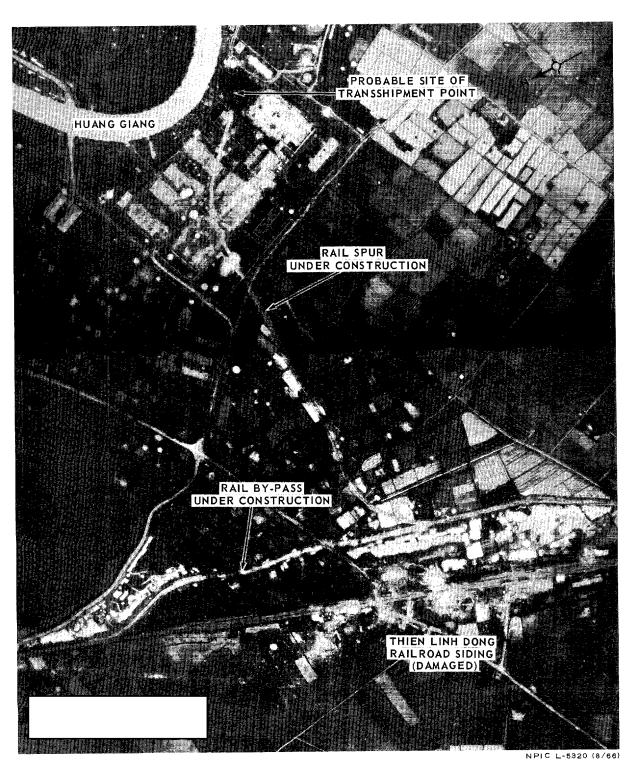
FIGURE 1. RAILROAD CONSTRUCTION, THANH HOA/VINH RAIL LINE, NORTH VIETNAM

A railroad by-pass is under construction around the damaged Thien Linh Dong Railroad Siding on the Thanh Hoa/Vinh Rail Line. The by-pass railbed extends east from the main line at UTM WG746804, then south to rejoin the main line at UTM WG745798. A rail spur under construction extends east from the by-pass at UTM WG746801 to the probable site of a water-to-rail transshipment point on the southeast bank of the Huang Giang (river) at UTM WG752802. Some ties, but no rails, have been laid on the by-pass and the spur (Figure 1). An additional rail spur in the early stage of construction extends northwest from the main line at UTM WG746808 to approximately UTM WG737813.

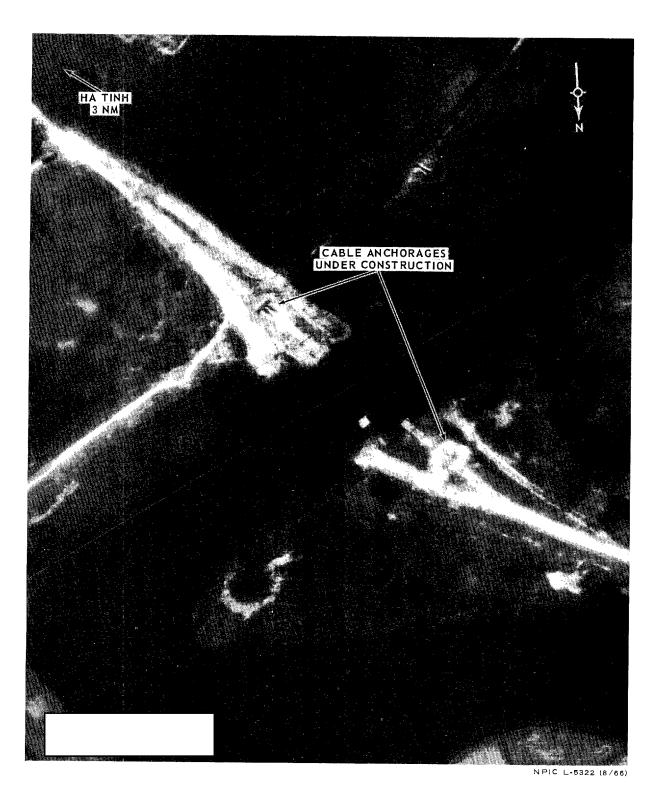
FIGURE 2. VEHICULAR CABLE BRIDGE UNDER CONSTRUCTION, ROUTE 1A, NORTH VIETNAM

A vehicular cable bridge is under construction at the destroyed Ha Tinh Highway Bridge West over the Song Chau Lam on Route 1A at 18-21N 105-52E (UTM WF921304). The cable anchorages are uncovered and are probably incomplete (Figure 2). A total of 27 vehicular and railroad cable bridges has been identified or confirmed by NPIC to date.

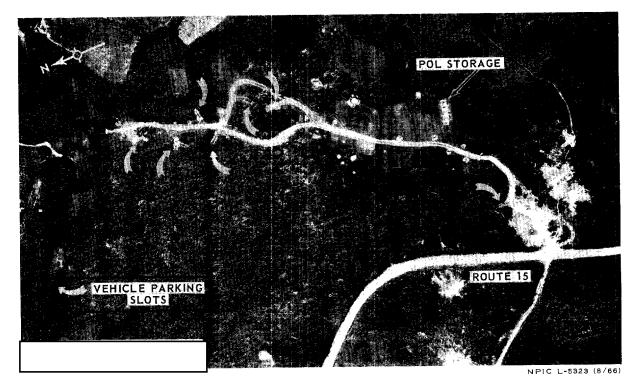
FIGURE 3. TRUCK PARK AND POL STORAGE AREA, ROUTE 15, NORTH VIETNAM

A small truck park with seven dispersed vehicle parking slots is located between Route 15 and Xom Ca Trang at 17-56N 105-49E (UTM WE868843). Two buried POL tanks and three empty excavations are observed in a POL storage area within the park (Figure 3).

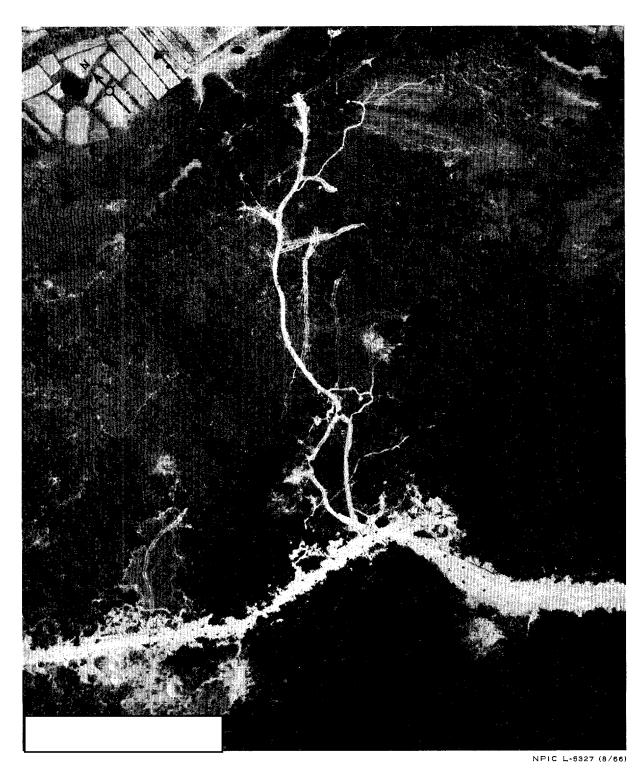
FIGURE 5. TRUCK PARK, ROUTE 108, NORTH VIETNAM

Route 108 remains under construction, although it is serviceable from Route 1A at 17-51N 106-26E to 17-59N 106-12E, the limits of photographic coverage. Road construction extends southeast from Route 108 at UTM XE474734 to XE476732, and a survey line continues to UTM XE479731. Multiple stream crossings are under construction in the vicinity of UTM XE465744. Six heavily camouflaged trucks are on the road between 17-57N 106-15E and 17-54N 106-19E. Five camouflaged trucks are observed in the vicinity of two occupied four-position light AAA sites, each with canvascovered positions, at UTM XE356854 and XE282896 (Figure 4). An active truck park is at UTM XE432786.

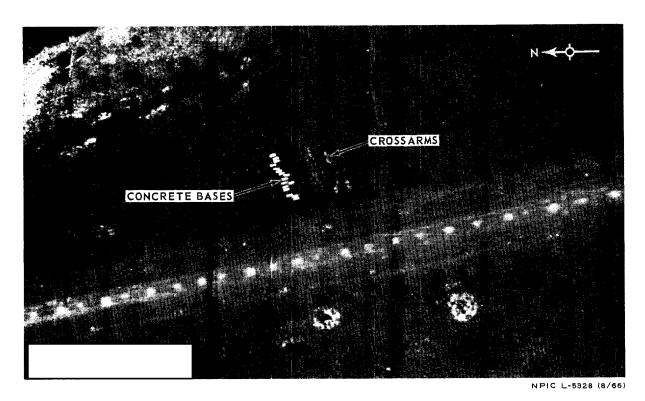
FIGURE 6. TELECOMMUNICATION POLES, ROUTE 1A, NORTH VIETNAM

Telecommunication poles are observed in North Vietnam approximately 3 nm north-northwest of the Line of Demarcation. Poles are observed paralleling Route 1A within the limits of photographic coverage from 17-04N 107-00E to 17-06N 106-58E. A total of 74 poles in seven piles are located along Route 1A from UTM YD106918 to YD086943 (e.g. Figure 6). Additional poles are aligned on the ground, obliquely crossing Route 1A from UTM YD112914 to YD103915 (Figure 7). All poles have round concrete bases; some have crossarms with varying numbers of insulators.
